Manhole Inspection Summary

Manhole # S23K__004MH

Insp Date: **6/10/08 9:45 AM**

Location Address: **333 S Gilmore St**

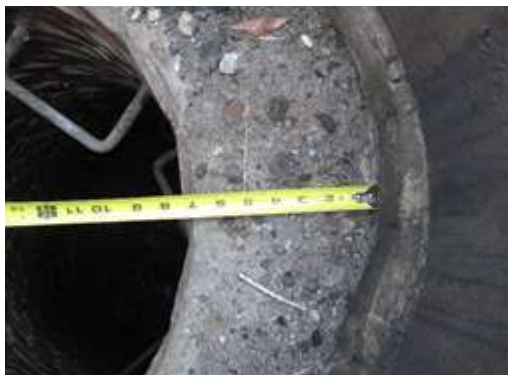
Offset: **7** (in.)

offset

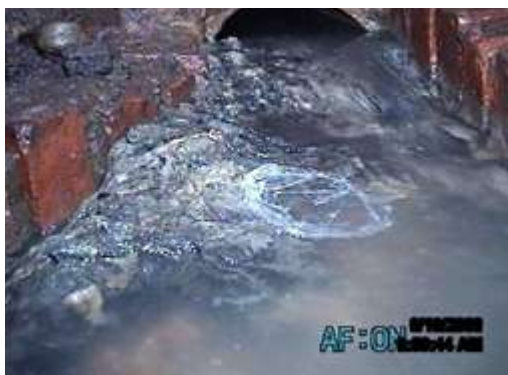
MISCELLANEOUS

heavey debri in channel

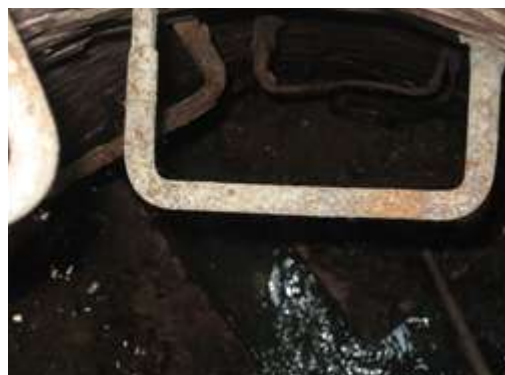
Defect 7

Count: **6** Missing: **0** ☒ **Corroded**

oxidized rungs, corroded rungs

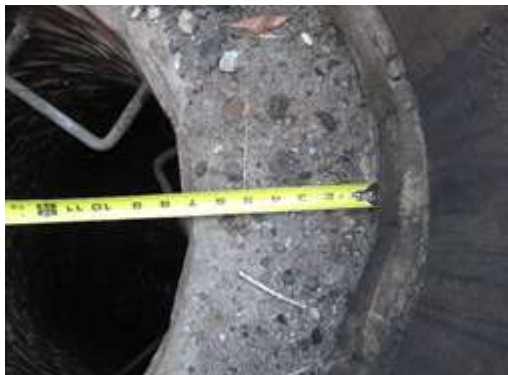
Defect 8

Frame offset 7"

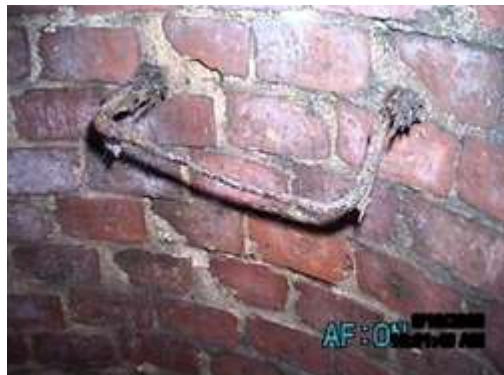
Defect 5

corroded rung

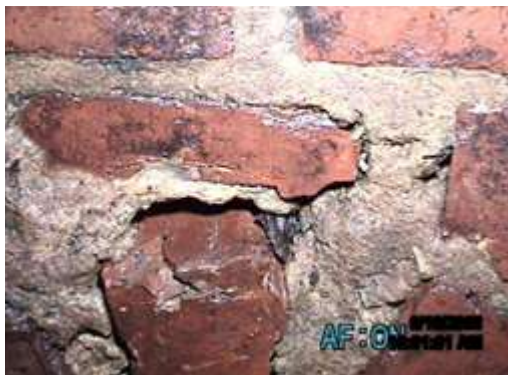
Defect 4

Condition: ☐ Sound ☐ Cracked ☐ Root Intrusion ☒ **Loose Brick** ☐ Deteriorated

Infiltration: ☐ None ☐ Joint ☐ Cracks ☒ **Mortar** ☐ Roots ☐ Wall

missing mortar loose brick
barrel,evidence of infiltration

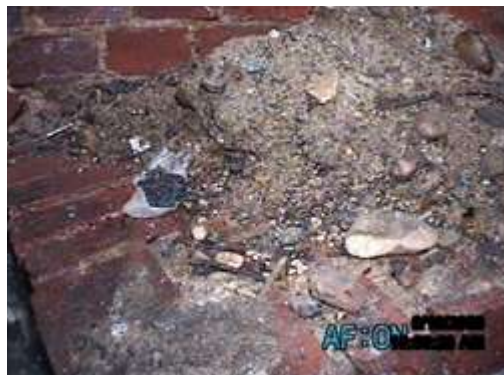
Defect 3

Condition: ☐ Sound ☐ Cracked ☐ Root Intrusion ☐ Deteriorated ☐ Leaks ☒ **Debris**

debris on bench

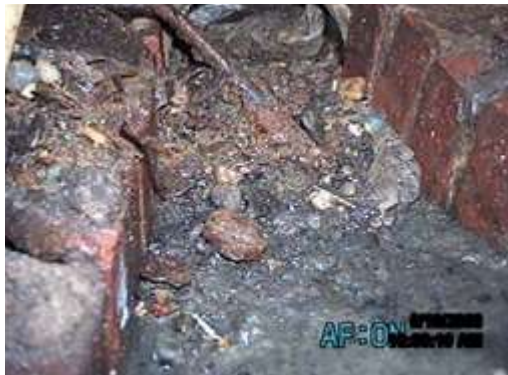
Defect 2

Condition: ☐ Sound ☐ Cracked ☐ Root Intrusion ☐ Deteriorated ☐ Leaks ☒ **Debris**

debris in channel

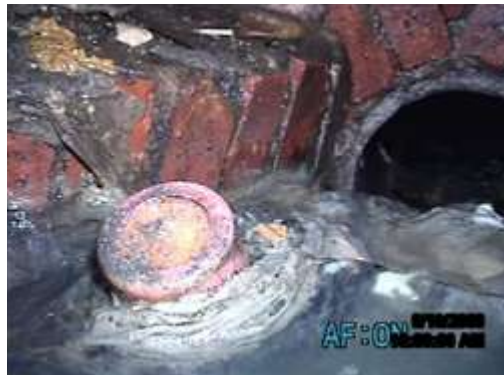
Defect 1

debris in channel

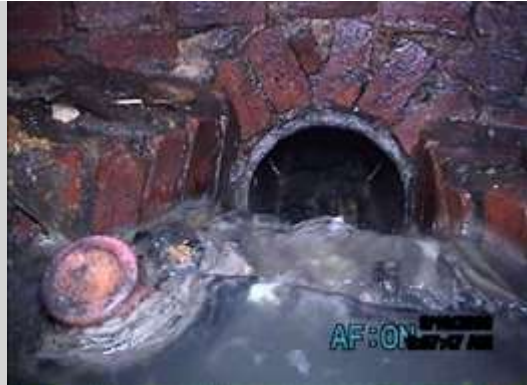
12 O'Clock Outflow

Pipe Height: **8.4** (in.) Rod and Bar (Angled)
Pipe Material: **Clay** ☐ Pipe Lined
Invert Depth: **11.91** (ft.) Flow Characteristics: **Fast**
Deposits: ☒ None ☐ Mud ☐ Sludge ☐ Debris ☐ Grease
Silt Depth: **0** (in.) Deposits Extent:
Infiltration: **None** Pipe Seal Cond: **Sound**

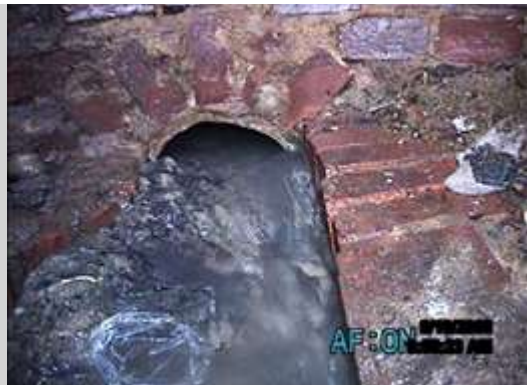
3 O'Clock Inflow

heavy debris in channel

Pipe Height: **6** (in.) Rod and Bar (Angled)
Pipe Material: **Clay** ☐ Pipe Lined
Invert Depth: **10.54** (ft.) Flow Characteristics: **Slow**
Deposits: ☐ None ☐ Mud ☐ Sludge ☒ **Debris** ☐ Grease
Silt Depth: **6** (in.) Deposits Extent: **Heavy**
Infiltration: **None** Pipe Seal Cond: **Sound**

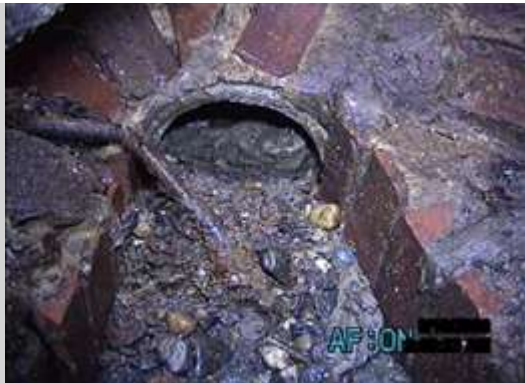
9 O'Clock Inflow

heavy debris in channel as well as pipe

Silt Depth: **6** (in.) Deposits Extent: **Heavy**
